## **Conservation Consulting Report**

Results of: Examination and Assessment of Rail Cars

Including Buildings, Rooms and Structures On-Site

Canadian Museum of Rail Travel

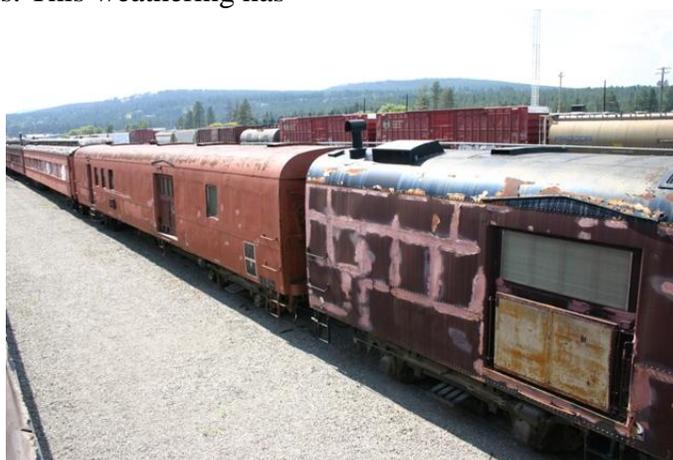
Overall view of weathered surfaces on Track #3.

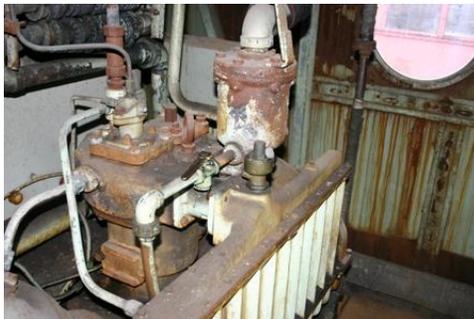
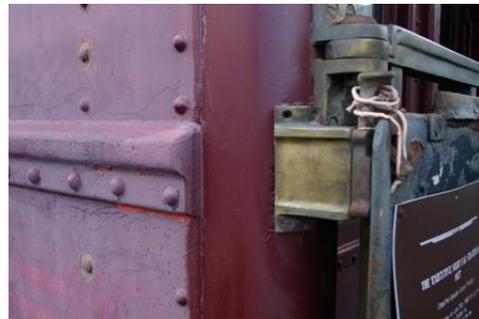
Metals in many forms exposed to environmental effects leading to deterioration

The varieties of metals in need of conservation treatment are large and the scale is considerable. Structural members with rust need attention to remove, clean and treat the metal. Tannic acid treatments are recommended for iron artifacts that are protected from the environment or are in locations not subject to direct moisture contact. Protective coatings for metals once they are cleaned and prepared for treatment are available for the range of artifacts that need to be re-coated.

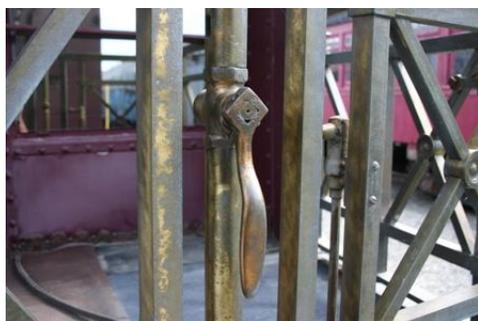
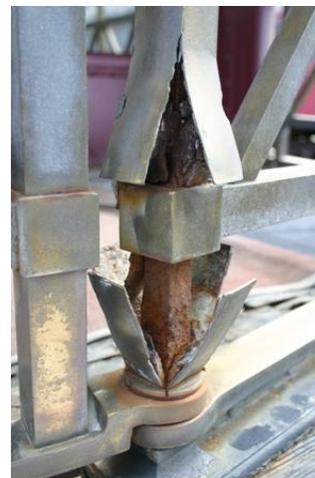
Mixed metals exposed to environmental conditions causing corrosion. Even though this deterioration likely started prior to the object coming to the museum, this is a classic example of what will continue to happen to exposed materials.

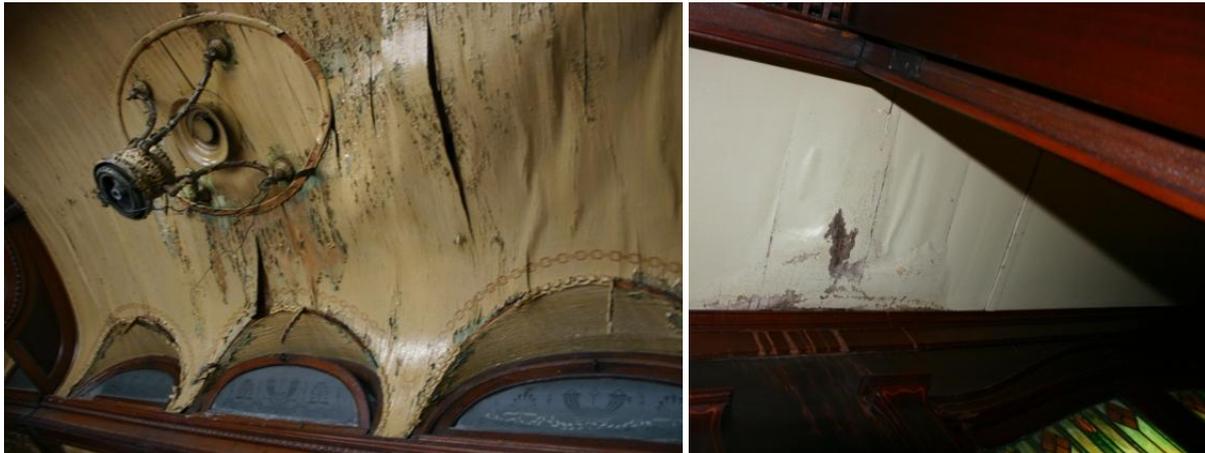
Leaking from rainfall and melting snow is the cause of extensive damage to interior ceilings, walls, furnishings that occurred prior to being in the CMRT care. Current protection efforts combined with enclosure of the cars will reduce possible repeat of this type of expensive damage.

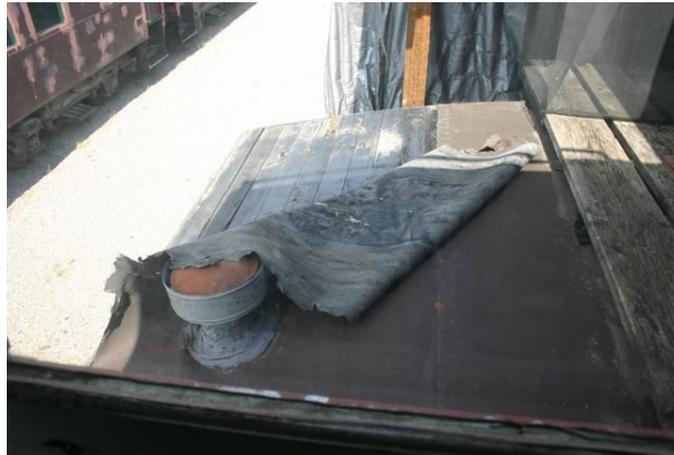
Roofing materials subjected to environmental degradation, weathering and effects of wind.

Once the repaint is completed then a final water repellent coating is sprayed on any areas that would have remained natural unpainted surfaces. The water repellent that is recommended here is a custom recipe now used especially for outdoor wooden surfaces and does not change or darken the appearance of the wood. The protection is provided to prevent free water from being so easily absorbed by the surface. Final finishing to the tops of the cars will involve attaching new zinc roofing covers where appropriate and required.

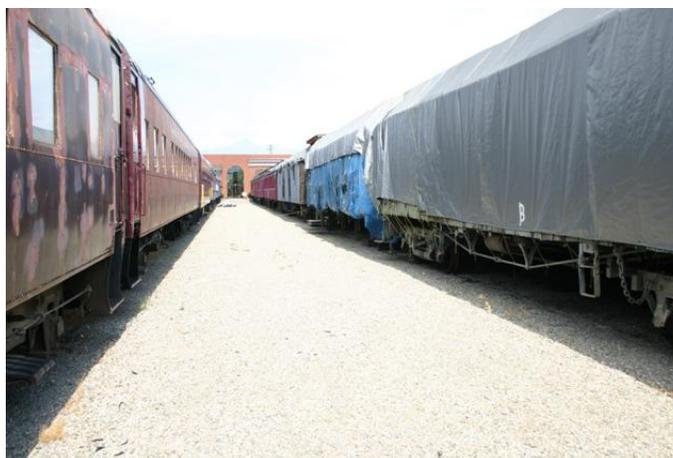
Temporary environmental protection on Track #2 with tarps is a band aid treatment.  
A building is the only viable long-term solution

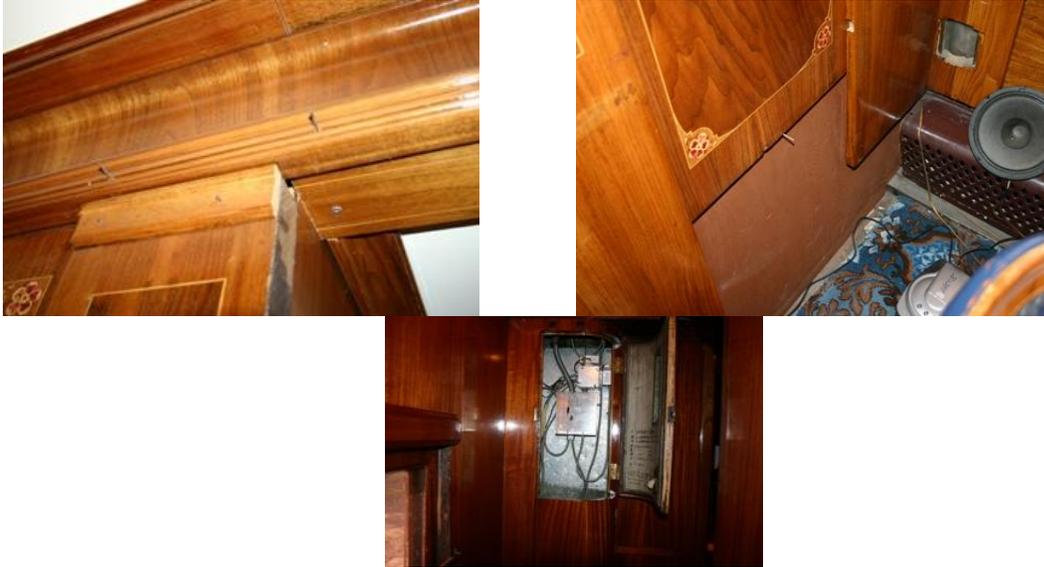
*Unfinished restoration awaiting skilled personnel.  
Some pre-laid coded wiring for future circuits*

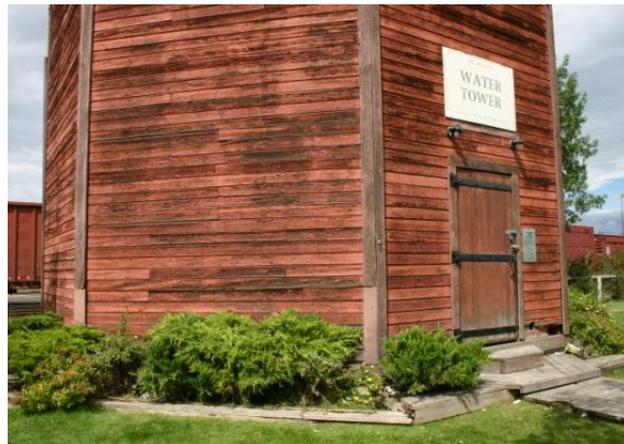
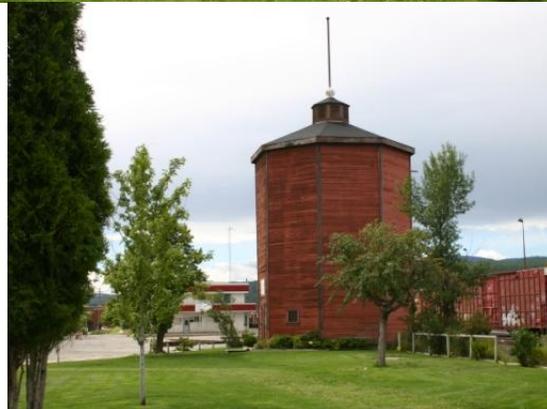
The Water Tower landmark of railway history showing some of the weathering of the prevailing wind.

Assessment of the Water Tower revealed weathering of surfaces and deterioration of the wood cladding. A few boards along the edges were loose and at least one vertical trim board was missing. Groundcover conditions are noted below for maintenance. An overall spray application of the borate treatment is recommended with a follow-up application of the custom water repellent. Treatment should extend the life of the material, but ongoing monitoring should take place and decisions made about replacing pieces that have deteriorated beyond repaint.

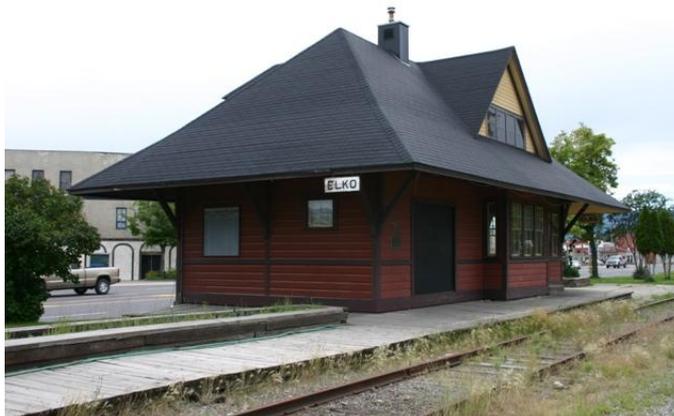
The Elko Station at the former Museum site

The Elko station was viewed from the ground and visual examination was assisted with binoculars. While generally in good condition as a result of previous restoration, some weathering was noted and in a few potential locations of ingress by pests and birds is a danger. Security and fire monitoring systems are in place.

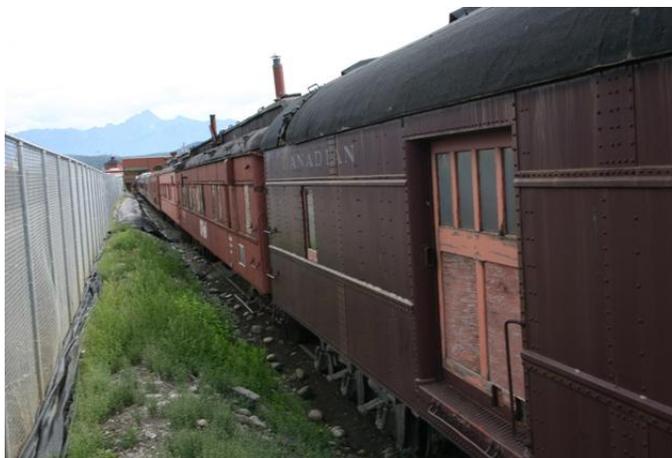
Northwest corner of site at present showing fence protection edge of Track #3  
Ground cloth, for weed control, has blown off the back berm due to wind,  
but is replaced as required
